## Repair & Strengthening

### References

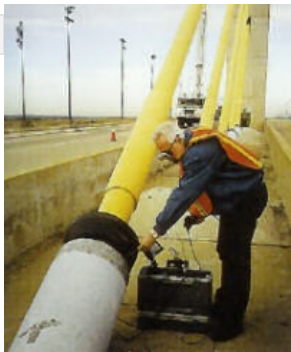
#### Mid Bay Bridge, Destin, FL

Inspection at anchorage areas of external tendons of the bridge and vacuum grouting of voids.

**i DSI Services** Inspection and Measurement of the Volume of Voids / Repair: Vacuum injected more than 700 voids Engineering: Assisted in preparing procedures for detensioning and replacement of 11 external tendons
