**■ Marine Structures****Reference Details:**

Rehabilitation of the Muldenberg Dam, Vogtland, Saxony, Germany

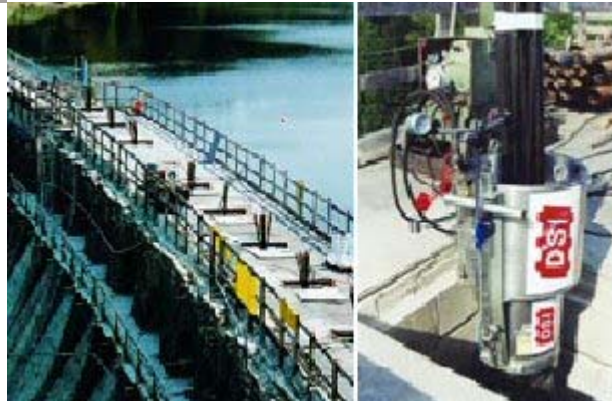
Rehabilitation works on the Muldenberg Dam using 19 permanent DYWIDAG Rock Anchors consisting of 21 strands Ø15.3 mm and in lengths of 42 m
